Subject: July and August 2017 Cultural Resource Monitoring Report for Expanded Area of Potential Effects
Leviathan Mine Site
Alpine County, California

Page 1 of 59 *Resource Name or #: Temporary # JDH_1702

P1. Other Identifier: Camp Isbell

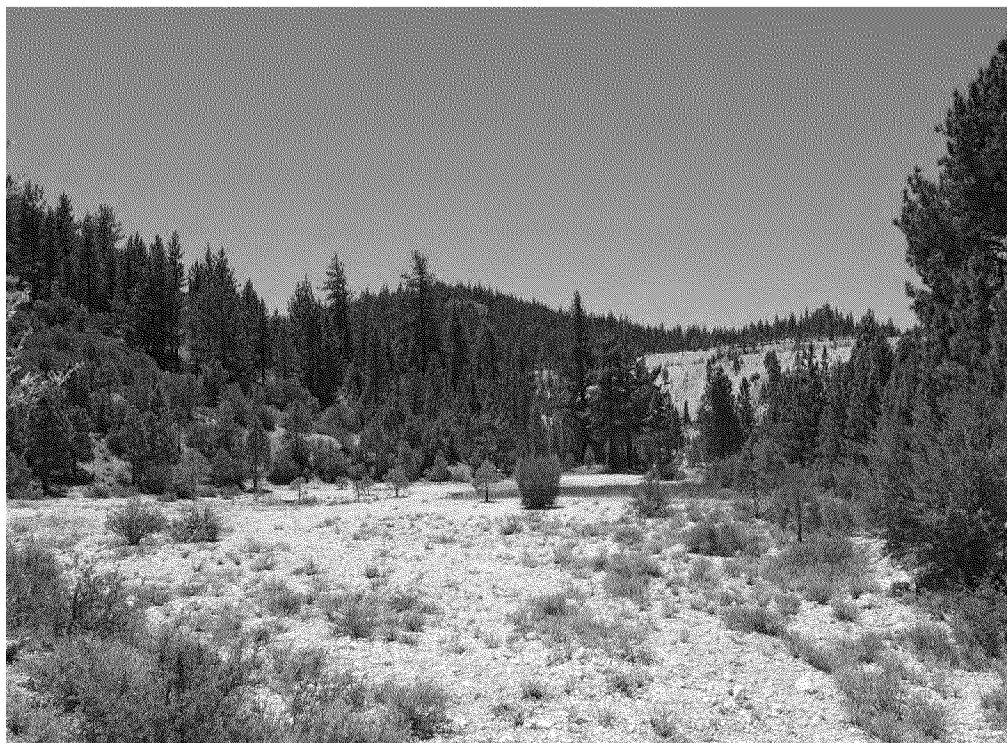
P5b. Description of Photo:
JDH_1702/Camp Isbell, Site overview,
facing south, 20170717_120616.jpg

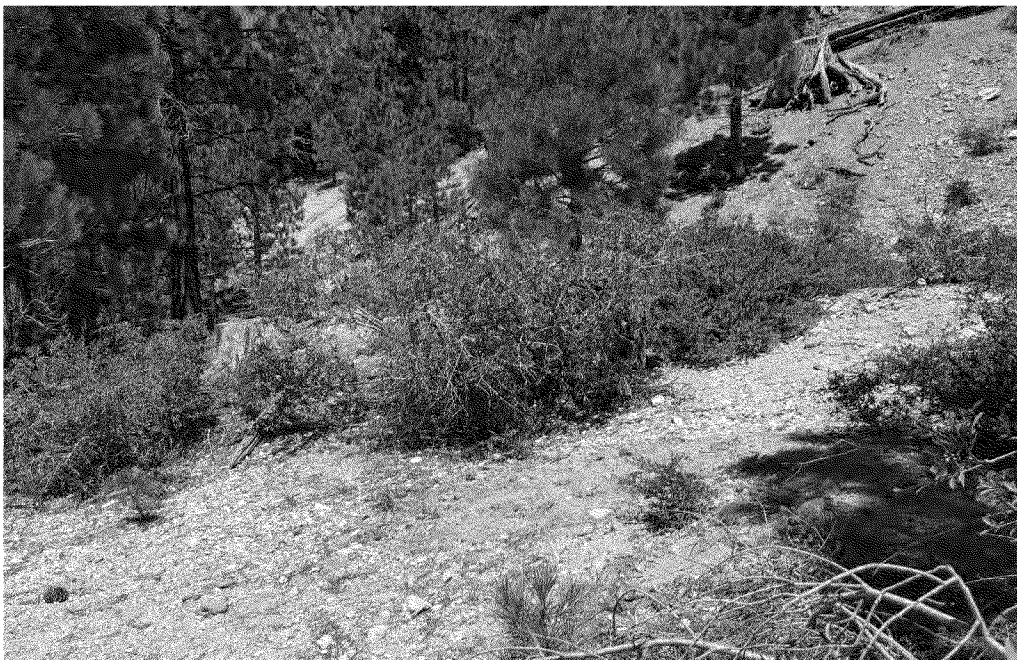
JDH_1702/Camp Isbell, Structure 'A' overview with cut stump adjacent to location where drums were once stacked, facing northeast, 20170717_135730.jpg

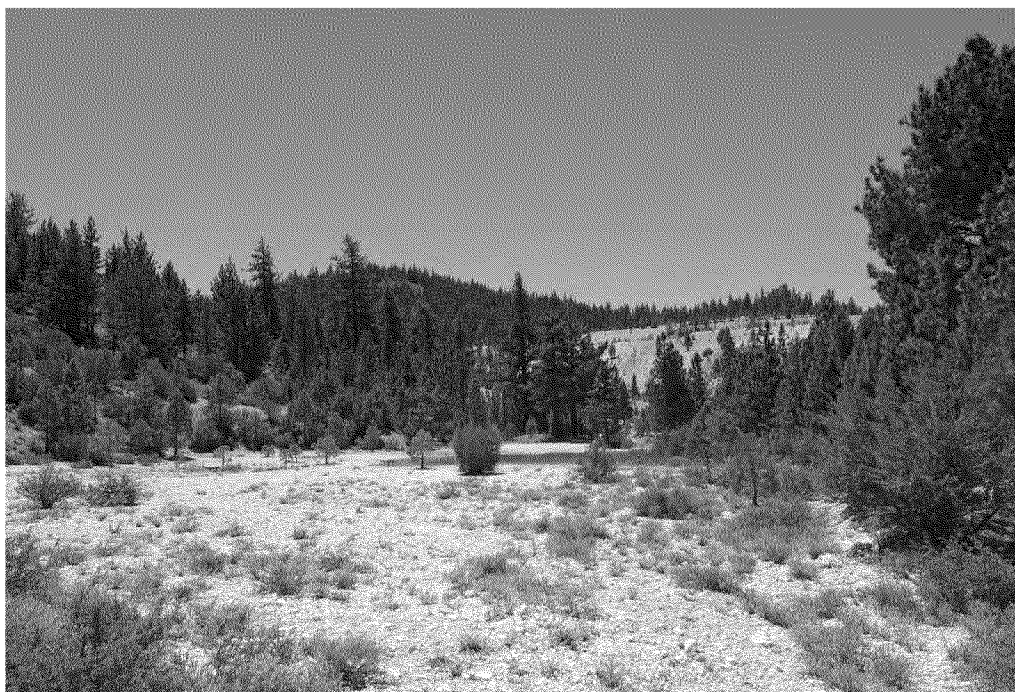
JDH_1702/Camp Isbell, Structure 'D' and Structure 'C' overview, facing south,
20170717_120616.jpg

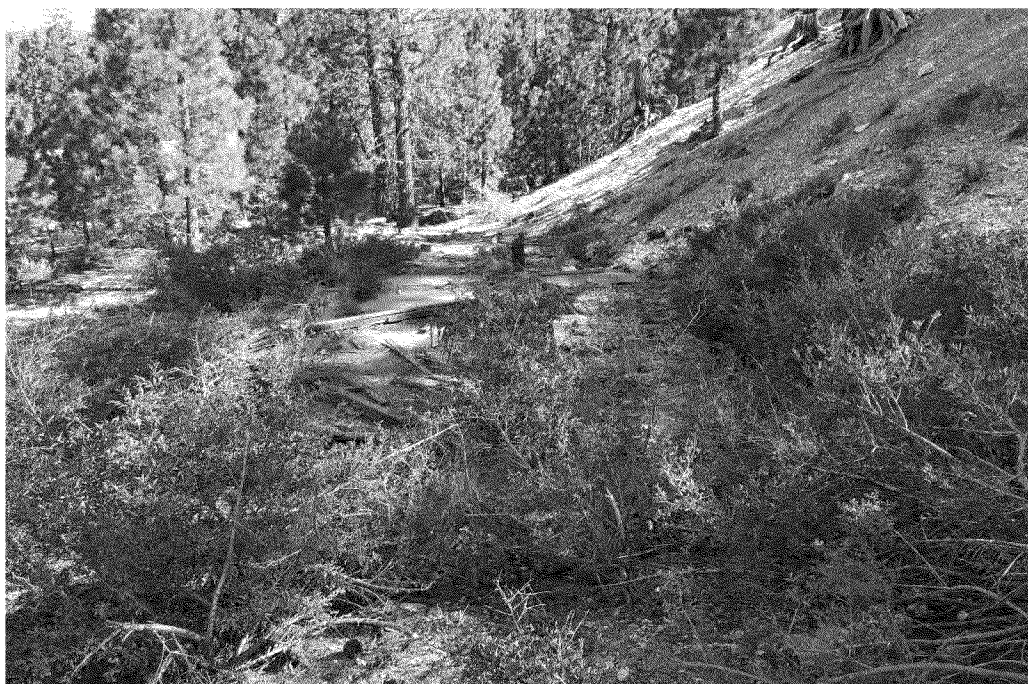
JDH_1702/Camp Isbell, Structure 'A' overview, facing north, 20170628_091807.jpg

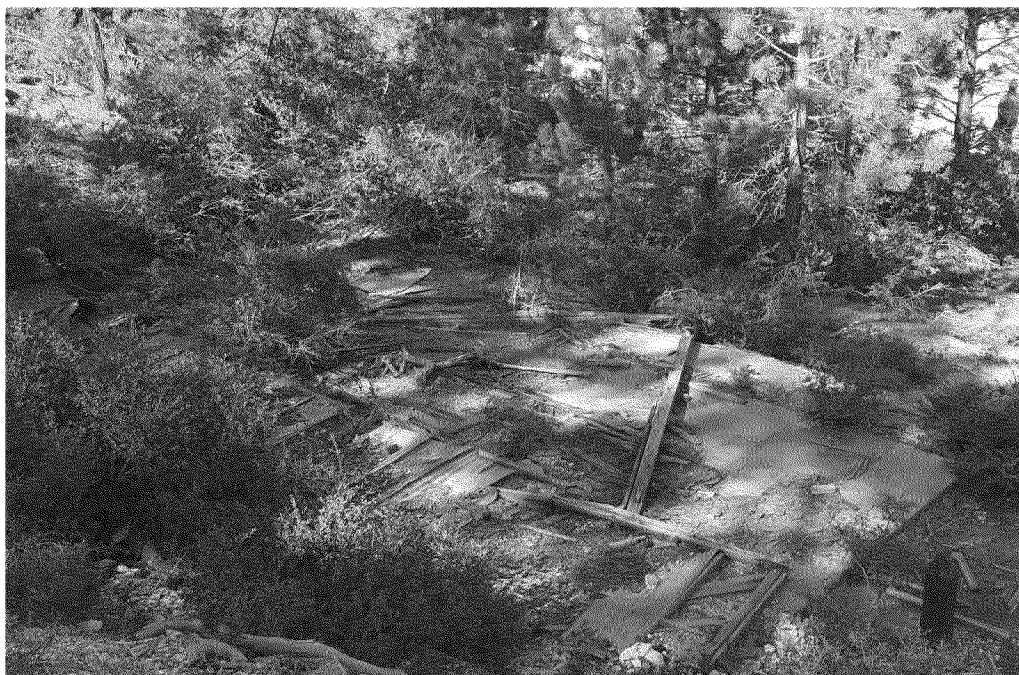
JDH_1702/Camp Isbell, Structure 'A' overview, facing south/southwest, 20170628_092046.jpg

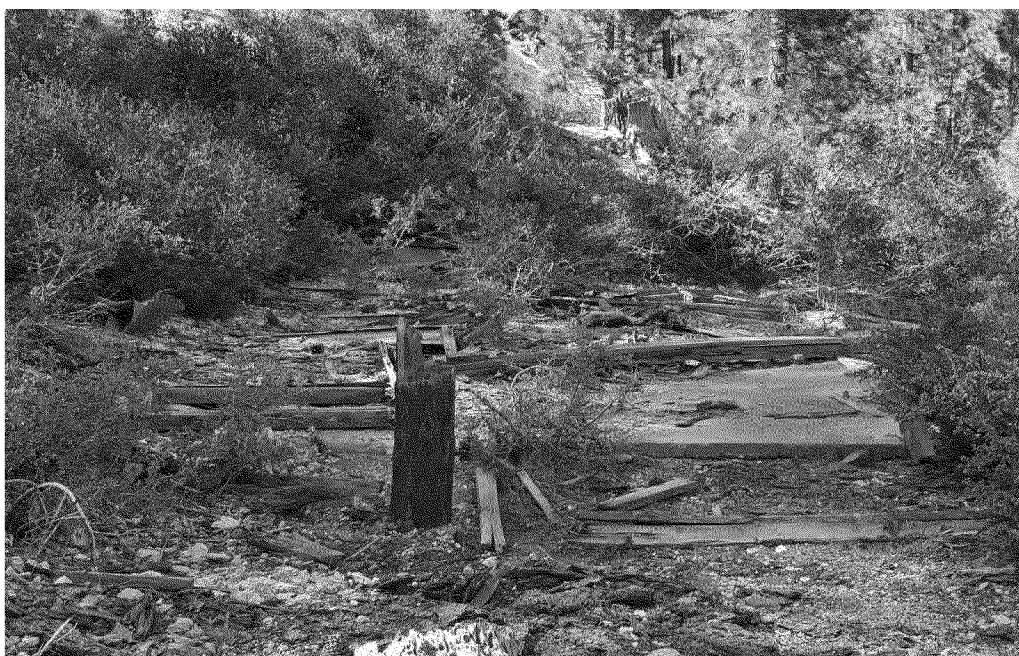
JDH_1702/Camp Isbell, Structure 'A' overview, south, 20170628_092230.jpg

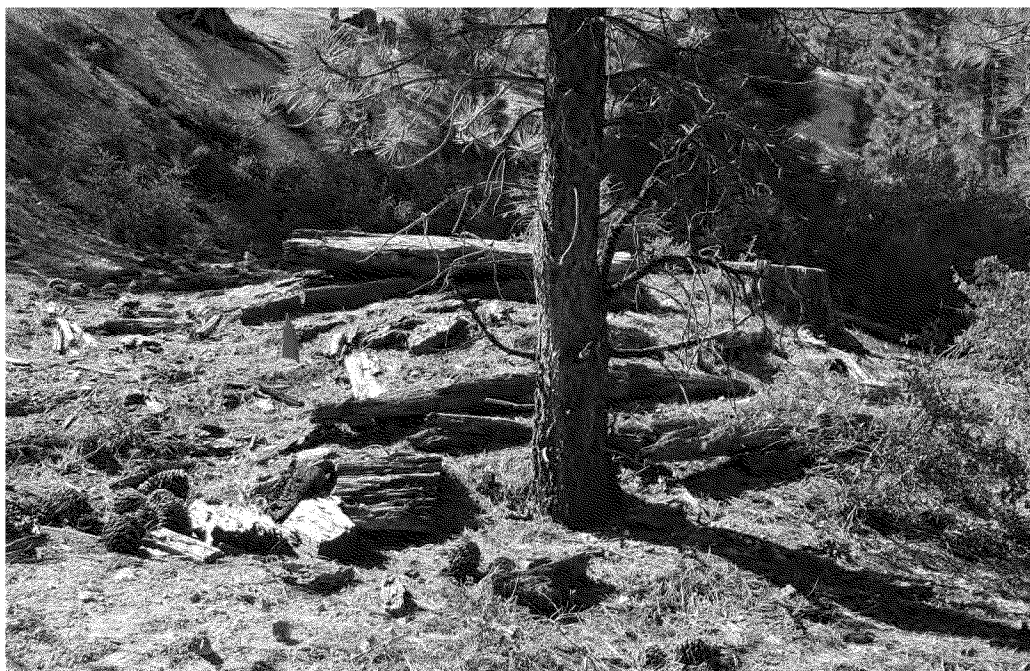
JDH_1702/Camp Isbell, Structure 'A' overview of approximate location of historic drum storage area, facing southeast, 20170628_092426.jpg

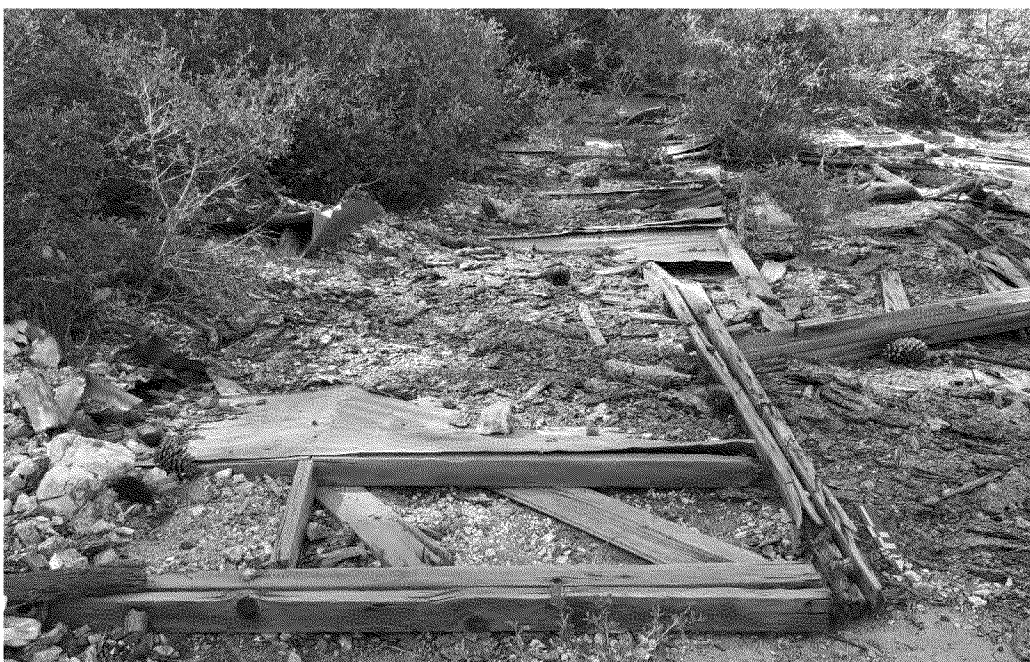
JDH_1702/Camp Isbell, Structure 'A', eastern portion structure detail, facing south
20170628_094446.jpg

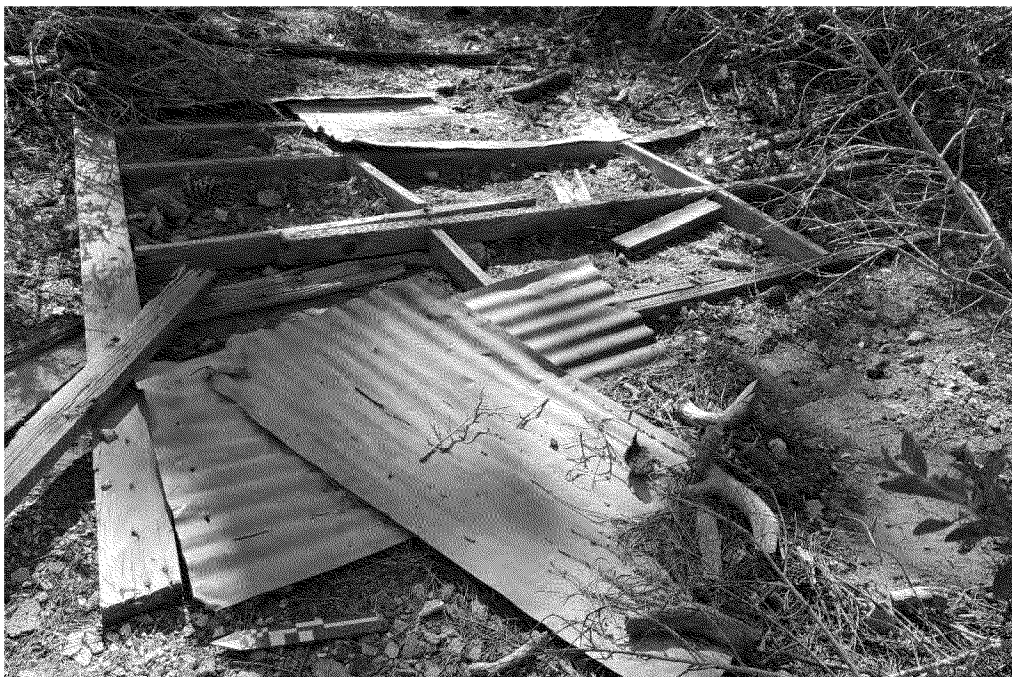
JDH_1702/Camp Isbell, Structure 'A', southern portion structure detail, facing east/southeast,
20170628_094727.jpg

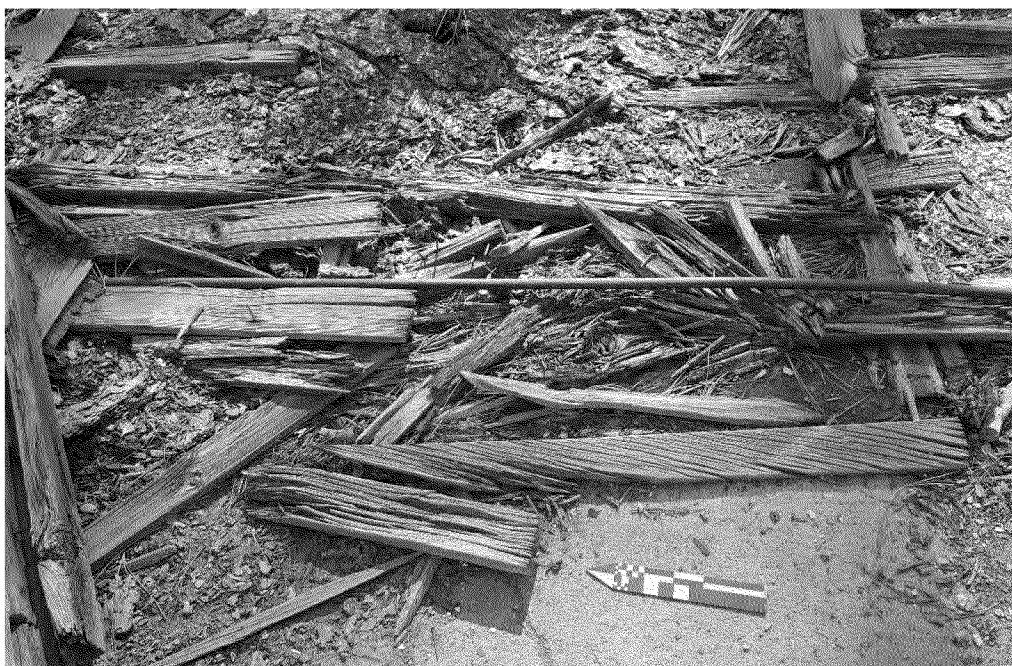
JDH_1702/Camp Isbell, Structure 'A', detail of screen door and structural debris, plan view,
20170628_093245.jpg

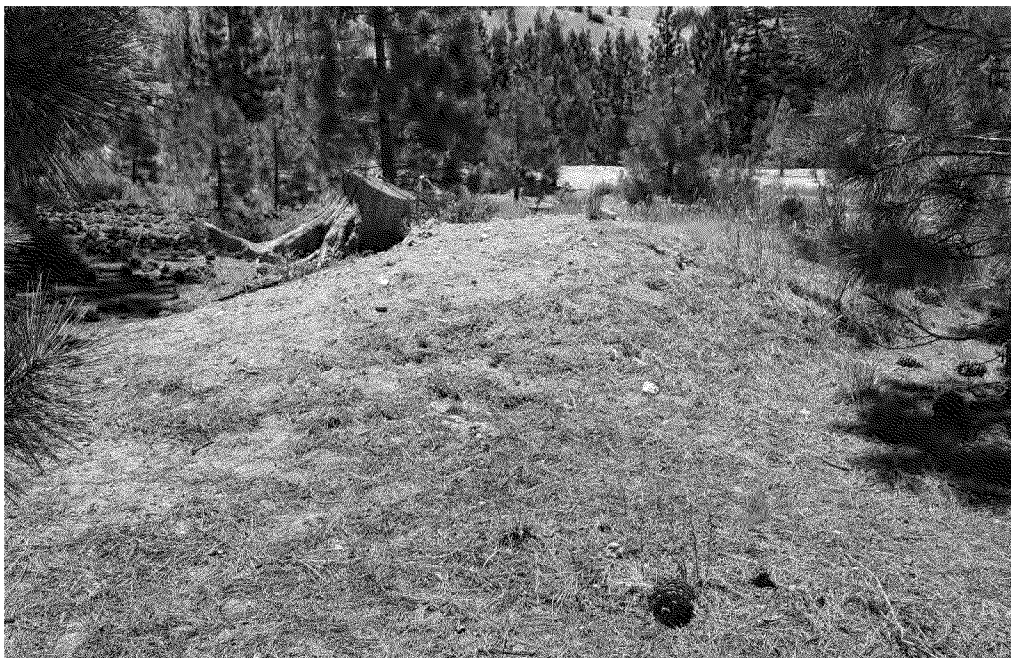
JDH_1702/Camp Isbell, Overview of Structure 'B' /Feature F-28 remains, push pile of debris, facing southwest 20170717_132710.jpg

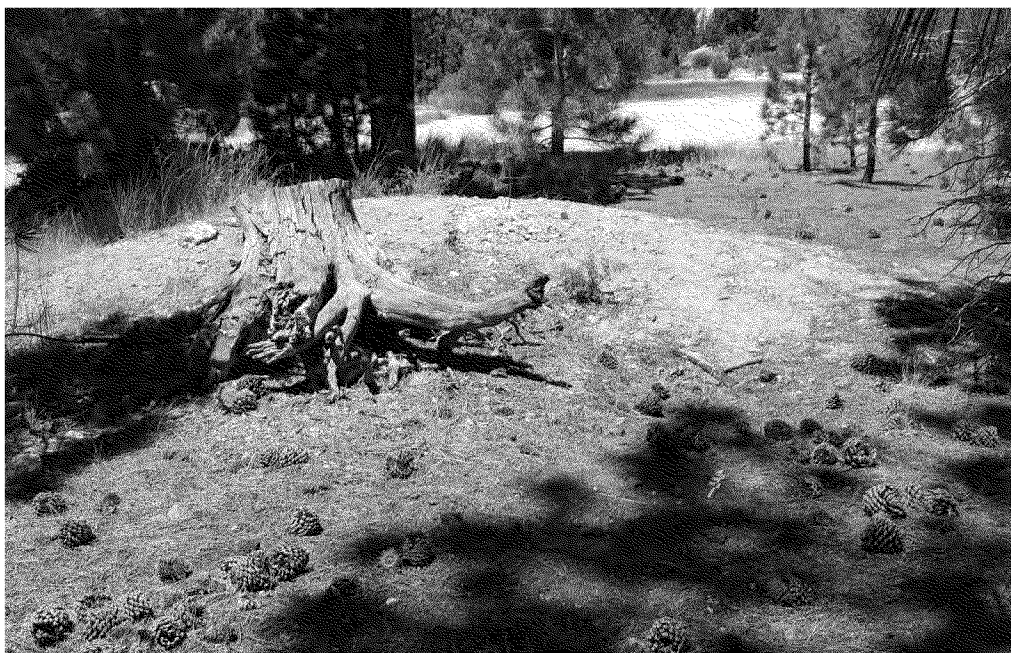
JDH_1702/Camp Isbell, Overview of Structure 'B' /Feature F-28 remains, push pile of debris, facing northwest-north, 20170717_132904.jpg

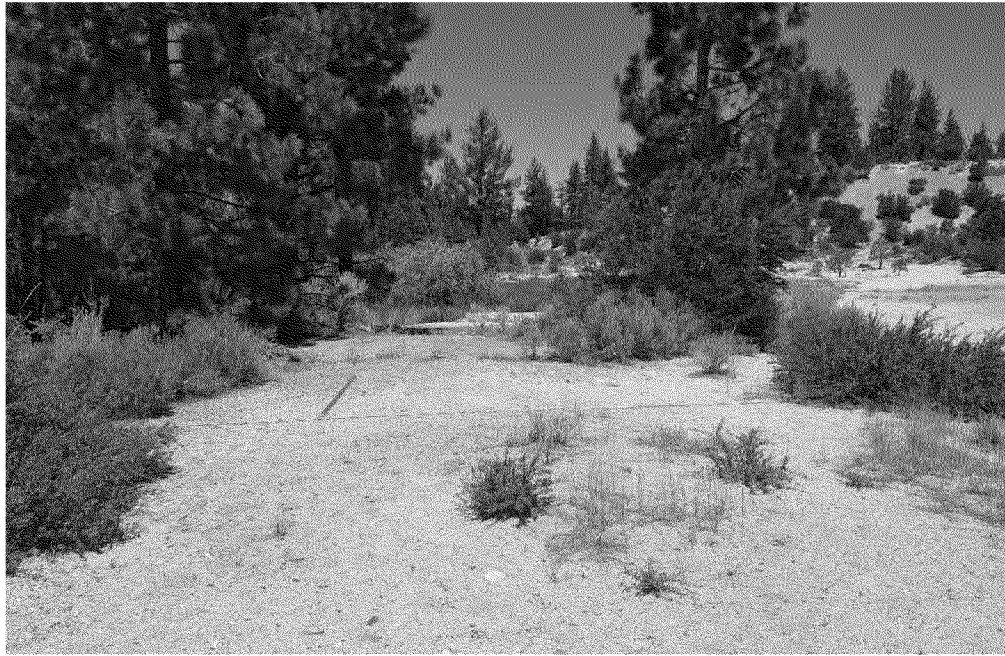
JDH_1702/Camp Isbell, Overview of intact portion of Structure 'C' foundation, facing northwest-north, 20170717_125251.jpg

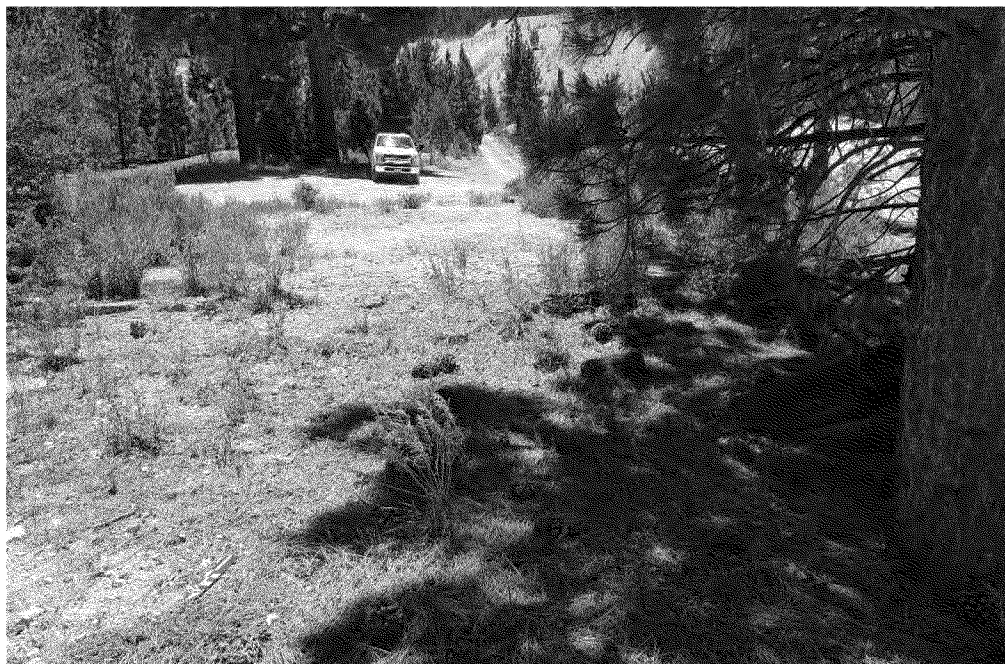
JDH_1702/Camp Isbell, Overview of intact portion of Structure 'C' foundation, facing south-southeast, 20170717_125415.jpg

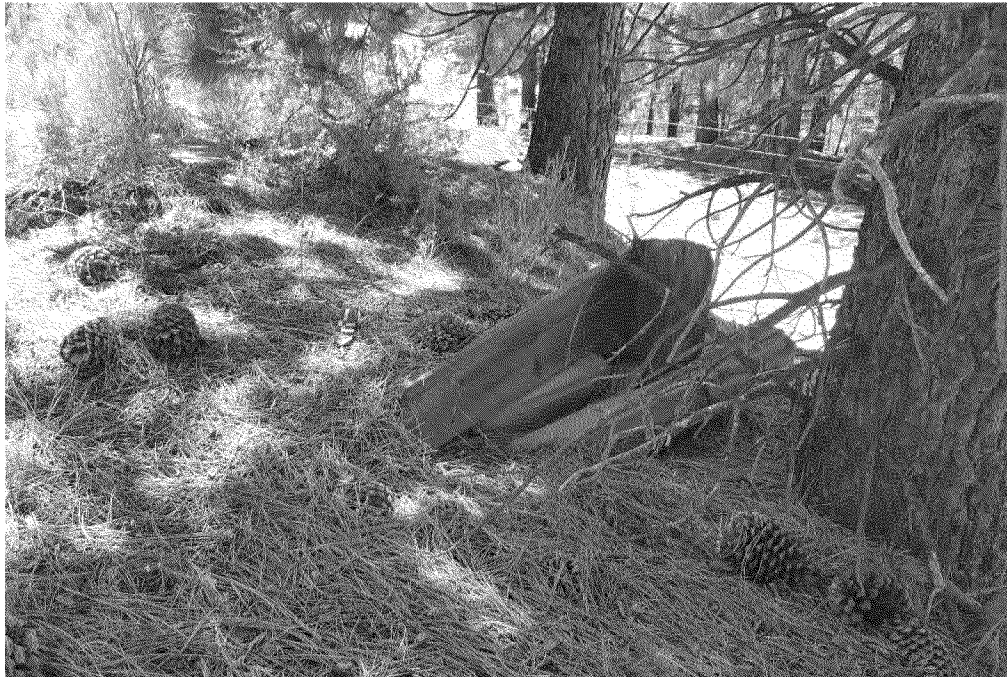
JDH_1702/Camp Isbell, Overview of intact portion of Structure 'C', retaining wall, northwest corner of Structure 'C', facing south, 20170717_125541.jpg

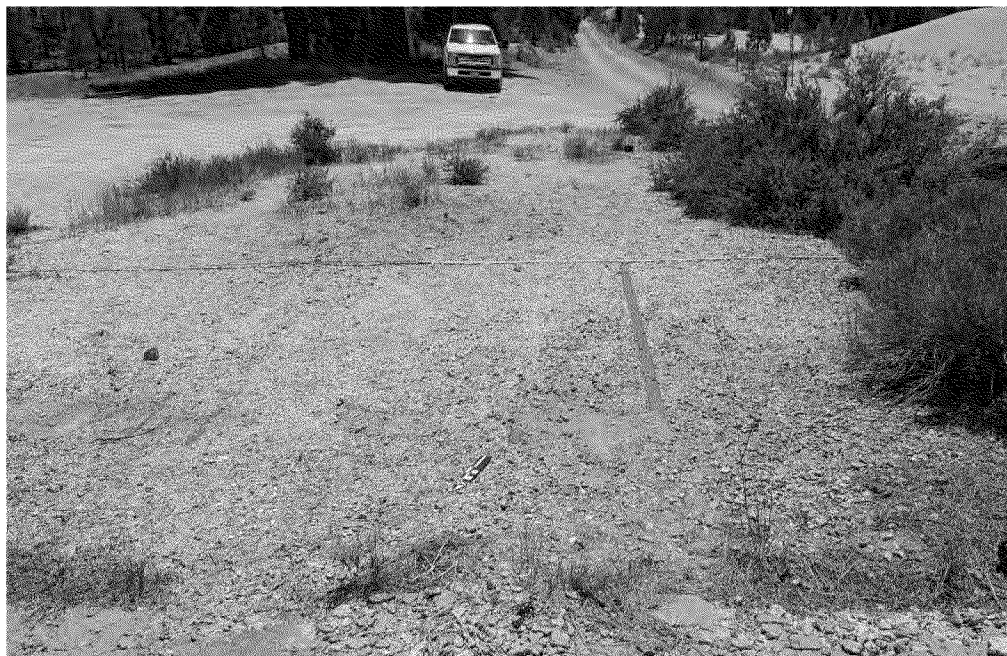
JDH_1702/Camp Isbell, Overview of intact portion of Structure 'C', I-beam reinforcements for haul truck/heavy equipment service entrance, facing south-southeast, 20170717_130706.jpg

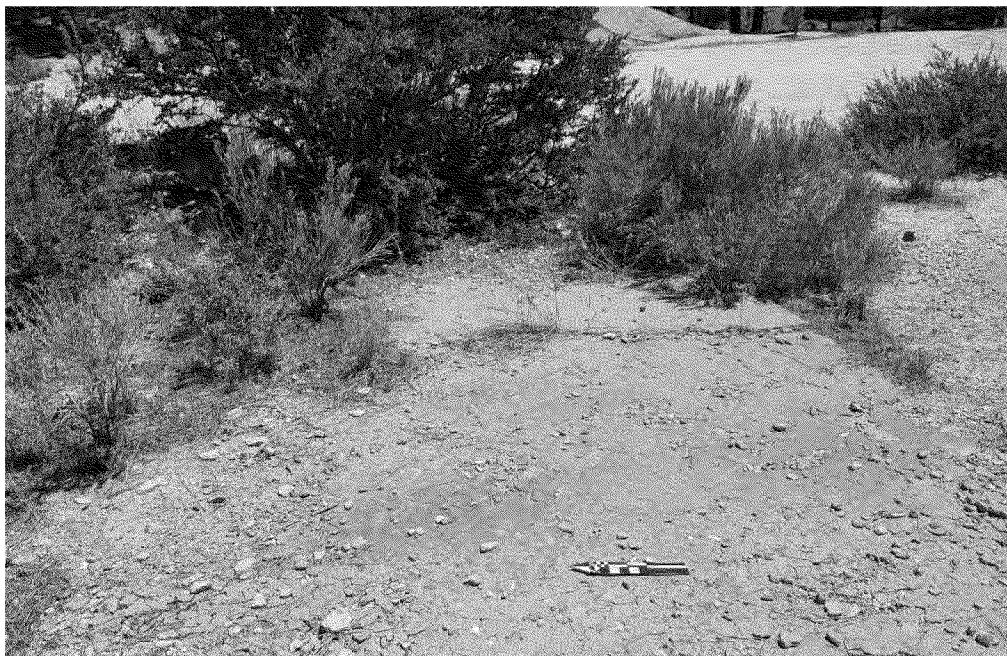
JDH_1702/Camp Isbell, Overview of intact portion of Structure 'C', intact portion of concrete foundation, facing east, 20170717_131440.jpg

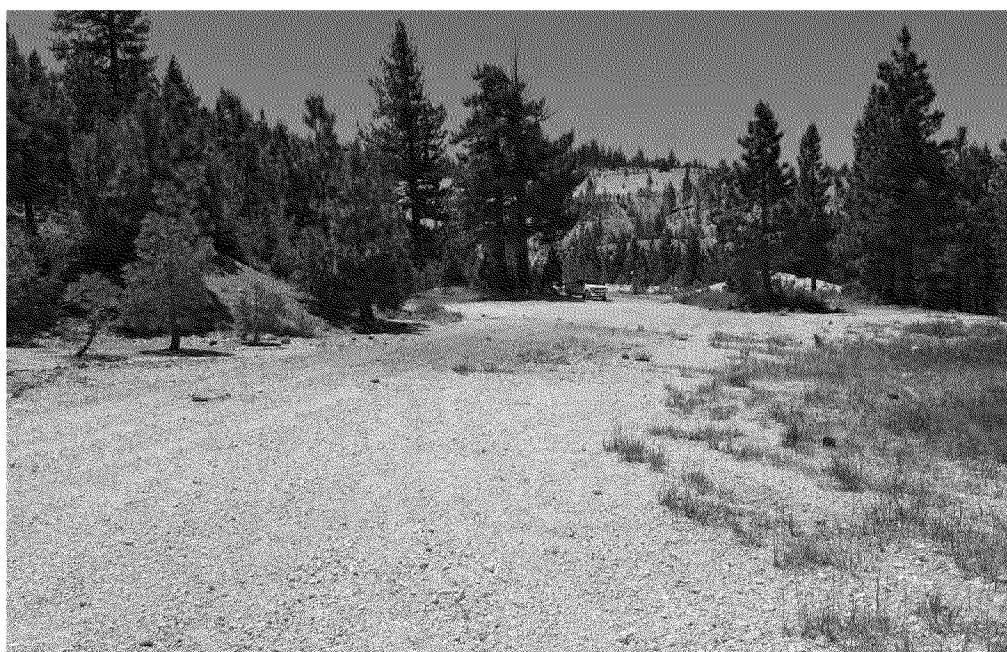
Structure 'D' is no longer extant. Slight staining on the ground surface. Please see photos for Structure 'D' on the Continuation pages.

JDH_1702/Camp Isbell, Overview of approximate location of Structure 'D' (no longer extant), facing south, 20170717_120858.jpg

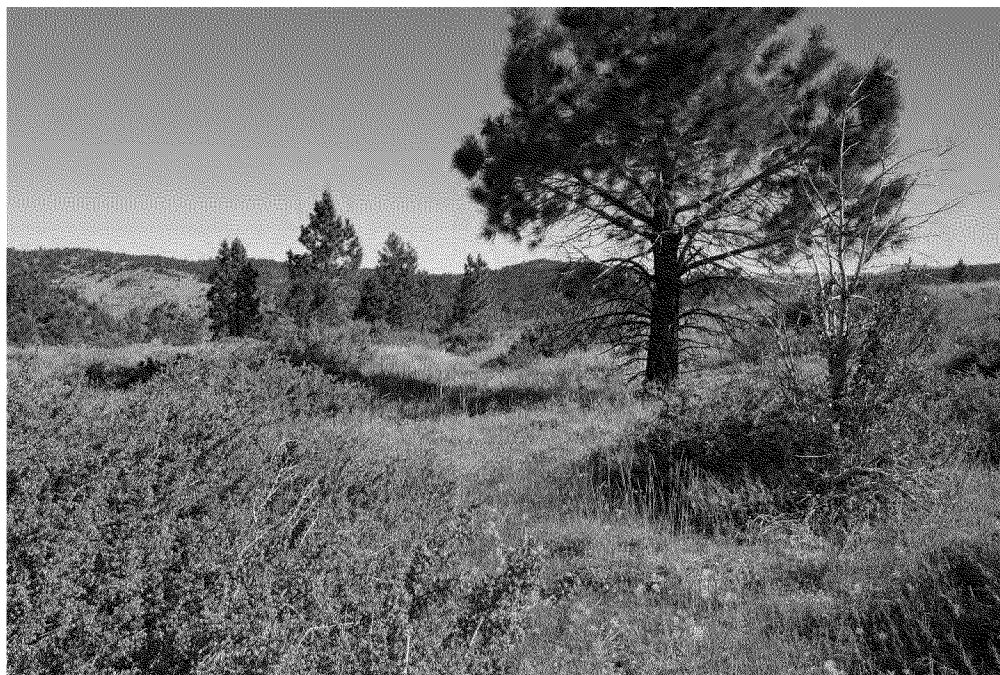
L7. Integrity Considerations: Low/none. Slope wash via snow melt and natural springs located within and adjacent to the site are eroding Feature F-01.

JDH_1702/Camp Isbell, Overview of Feature F-01 (ditch), facing north, 20170717_091246.jpg

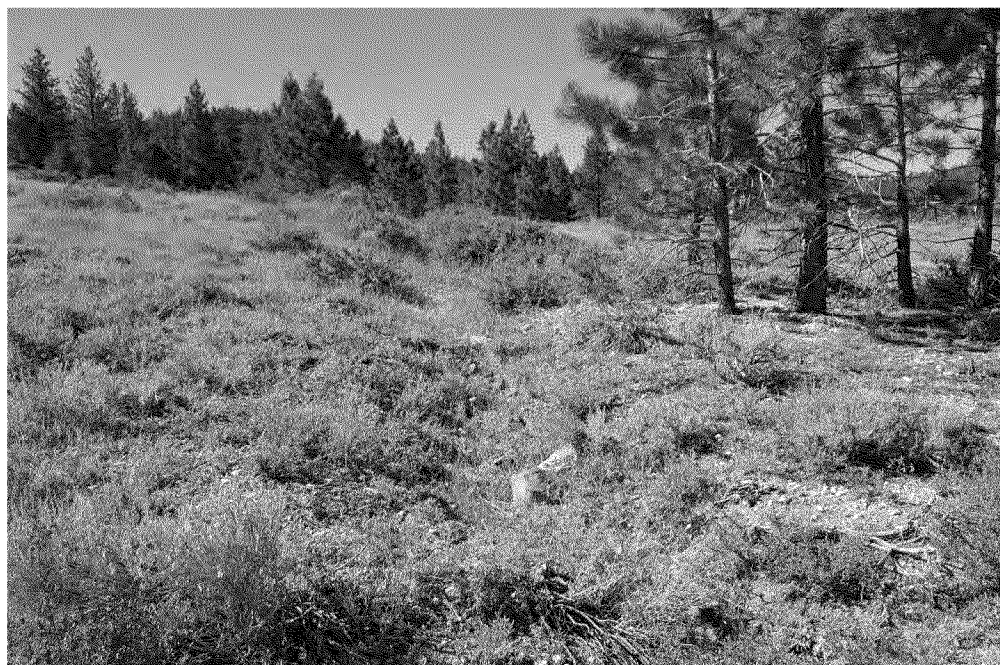
JDH_1702/Camp Isbell, Overview of Feature F-01 (ditch), facing south, 20170717_091511.jpg

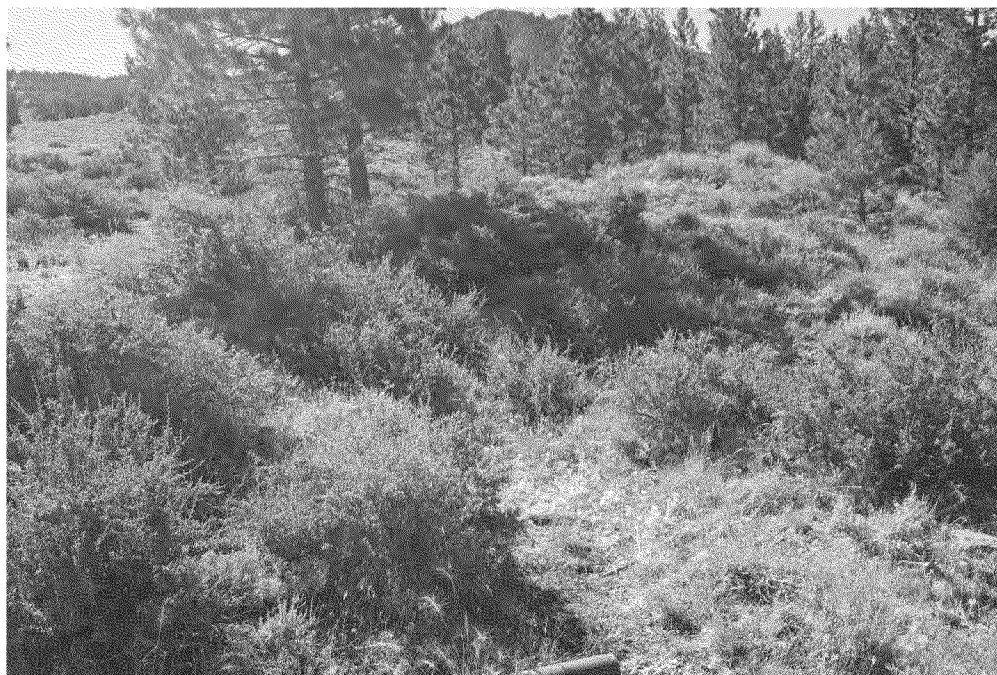
L7. Integrity Considerations: Low/none. Slope wash via snow melt and natural springs located within and adjacent to the site are eroding Feature F-02.

JDH_1702/Camp Isbell, Overview of start of Feature F-02 (ditch) with Feature F-05 (concrete cistern) and F-02a (imbedded pipe), facing southeast, 20170717_091825.jpg

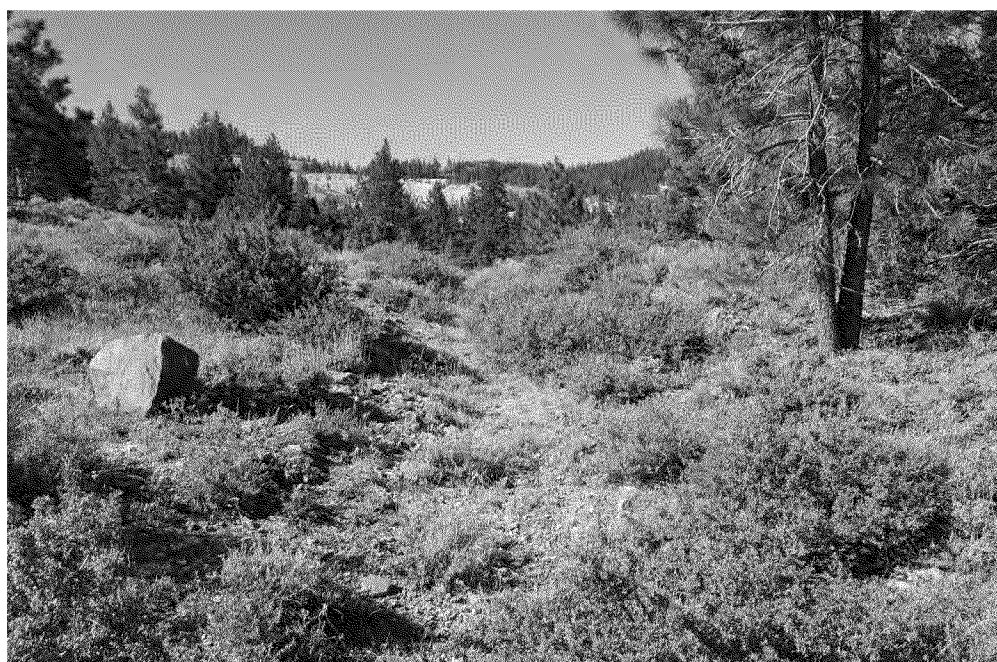
JDH_1702/Camp Isbell, Overview of terminus of Feature F-02 (ditch), facing south-southwest, 20170717_091656.jpg

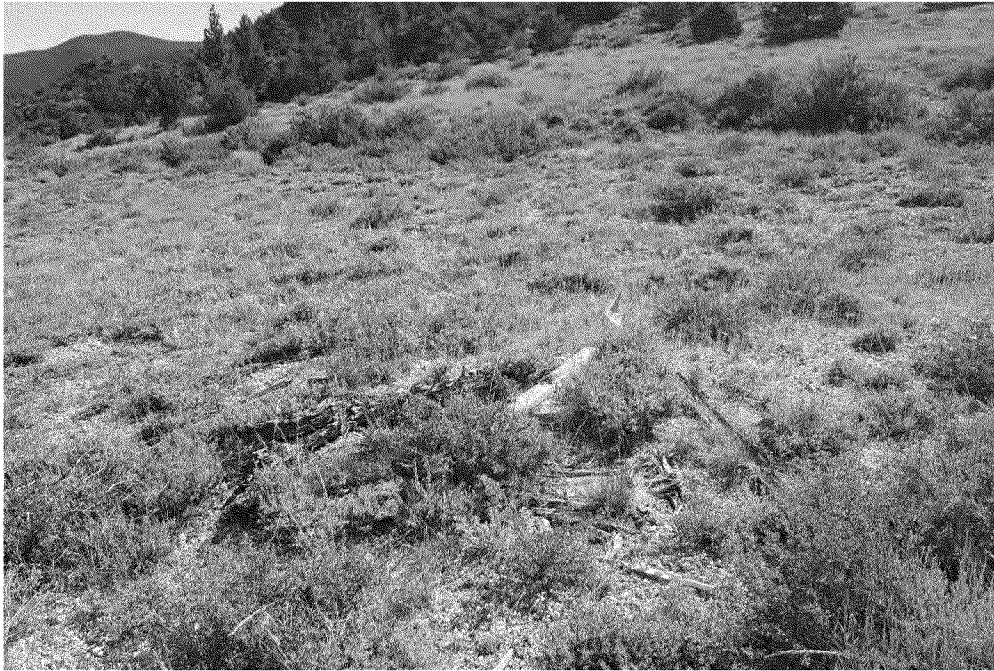
JDH_1702/Camp Isbell, Overview of Feature F-03, lumber and debris, facing northeast,
20170717_092145.jpg

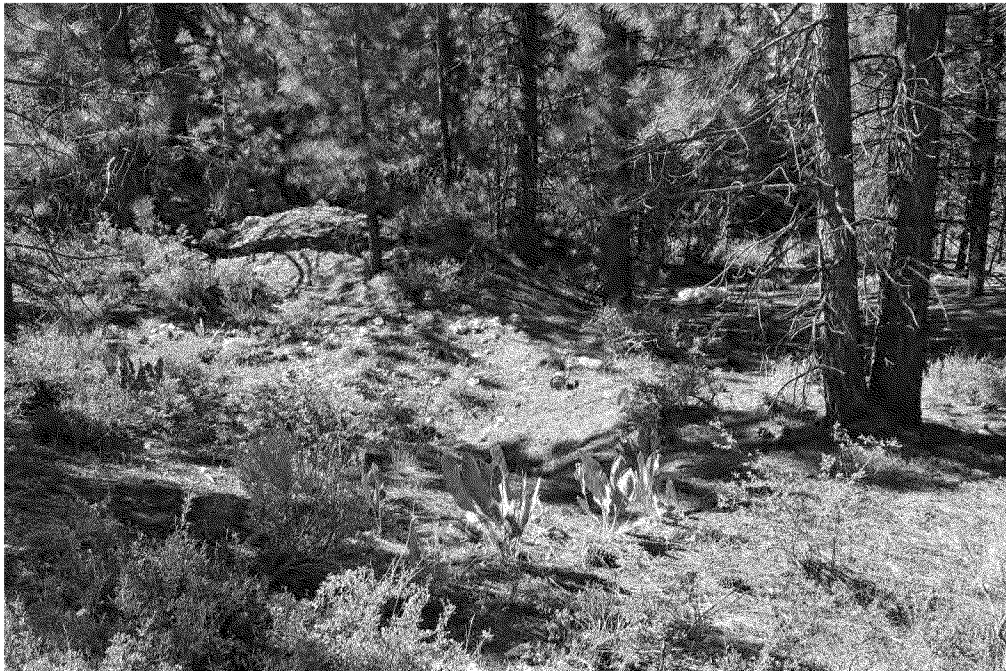
JDH_1702/Camp Isbell, Overview of Feature F-14, culvert with push pile and associated artifacts, facing southeast-south, 20170717_100244.jpg

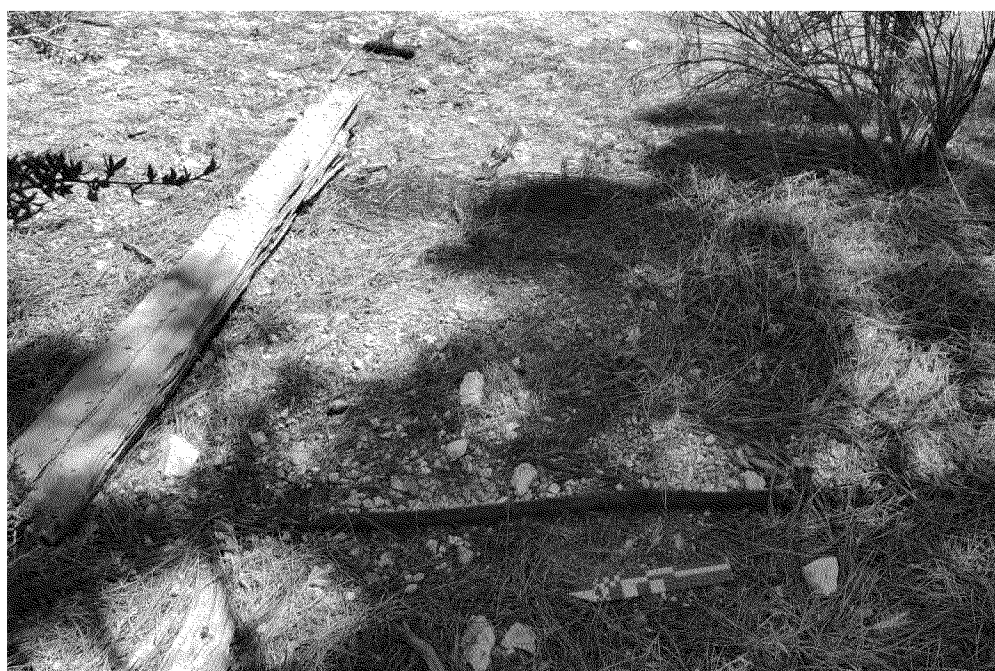
JDH_1702/Camp Isbell, Overview of Feature F-21, partially buried shaker screen, facing east,
20170717_113738.jpg

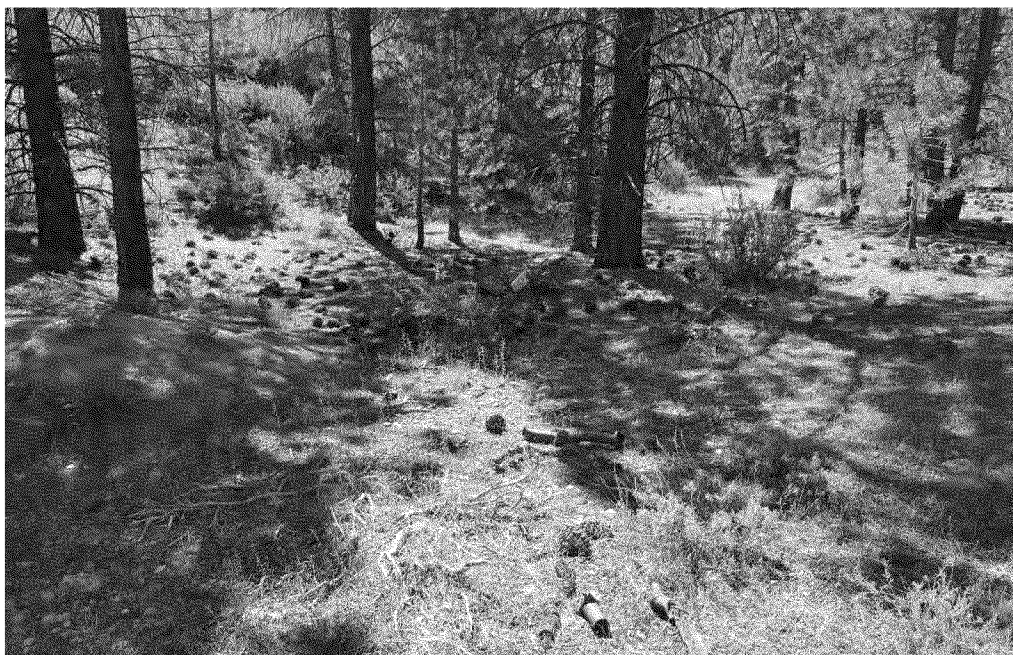
Feature F-034 is an artifact concentration that consists of historic residential debris and automobile parts. The artifacts present are mostly non-diagnostic, and present no definitive temporal information that has not otherwise been garnered, but contains several unique items that provide a more complete “snapshot” of the time period and activities and individuals involved. Contained within Feature 34 are the fragments of several exhaust systems for period automobiles, a muffler (corroded into 6 parts), 6 colorless bottle glass fragments (heel and neck fragments), 3 porcelain fragments (base fragments-mug sized), a crushed sanitary can (3 and 7/16 of an inch diameter) , a pair of children’s boots 5 and 14/16 of an inch long by 2 and 8/16 of an inch wide- with a red rubber sole and with white leather uppers with white metal eyelets, a child’s sandal 4 inches long by 2 and 8/16 of an inch wide- with pink leather sole and blueish cut out upper, with toe strap and metal buckle, a plank fragment, 3 interlocking-tab seam crushed beverage cans- 2 and 12/16 of an inch in diameter, a screw cap for a lawn mower gas tank or portable gas can- 1 ¾ of an inch in diameter, and an aluminum trash can lid- 18 inches in diameter.

JDH_1702/Camp Isbell, Overview of Feature F-34, historic debris, facing northwest,
20170717_103412.jpg
